# OPERATING EXPERIENCE SUMMARY

**Office of Nuclear and Facility Safety**

**Summary 99-47**

# Operating Experience Summary 99-47

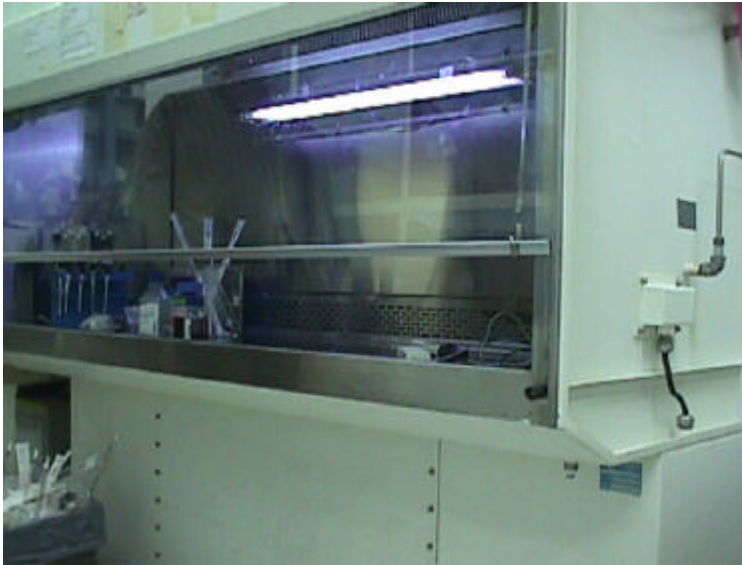
**Figure 1-1. Ultraviolet Light Inside Laminar Flow Hood**

In the first event investigators determined that although the work order did not include a statement about the ultraviolet safety hazard, the light fixtures were clearly labeled with a hazard warning, which stated that power should be turned off before changing a lamp. They determined that after the electricians installed the light fixtures they kept them activated for 2 hours while they installed a safety interlock system designed to protect personnel from ultraviolet exposure. In the second event investigators determined that three Y-12 Facilities Maintenance machinists were reinstalling HEPA filters in a laminar flow hood that uses an embedded germicidal ultraviolet light to preserve living cultures. They also determined that the germicidal light is activated manually with a light switch when the hood is not being used and that the hood has a clearly visible warning label defining the ultraviolet hazard. Investigators determined that the machinists received a hazardous level of ultraviolet radiation when they removed the front panel of the hood to gain access to the HEPA filters and failed to turn off the switch to deactivate the germicidal light.

These occurrences highlight the need for stringent safety practices when working with UV. When personnel must work near energized UV light sources, extra precautions should be taken to avoid exposure. As illustrated in these events, the consequences of exposure may not be immediately apparent. Managers of facilities using lasers should ensure that experimenters use hazard controls appropriate for UV operations. Control measures include (1) engineering controls, such as interlocks; (2) administrative controls, such as lockout/tagout of light power sources, procedures, warning signs, labels, and training; and (3) personal protective equipment, such as eyewear, and special clothing.

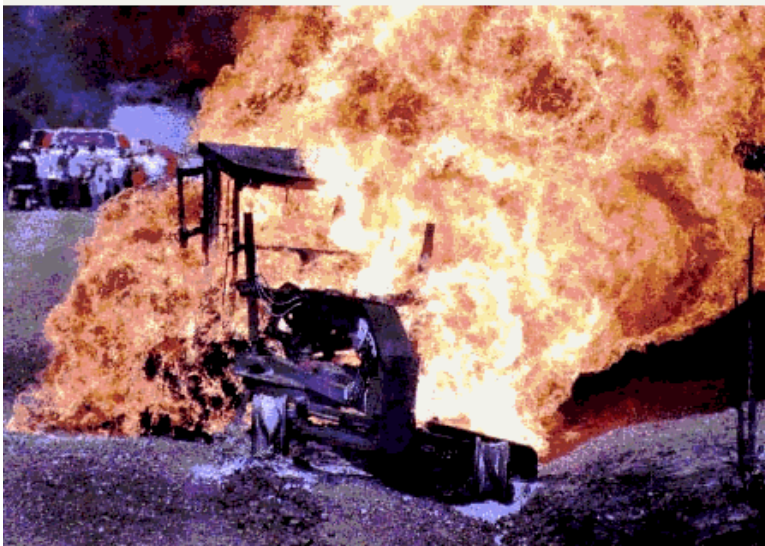
**Figure 7-1. 1989 Pipeline rupture and fire in Lebanon, Missouri**

Natural gas explosions can cause significant damage and loss of life. On December 11, 1998, in St. Cloud, Minnesota, workers attempting to lay a fiber optic cable cut a gas main, resulting in an explosion. The blast leveled three buildings, killed 4 people, and injured 10 others. Bureau of Labor Statistics data on construction-related occupational injuries show that in 1996, 50 fatalities were attributable to excavation work. Figure 7-1 shows a 1989 event at Lebanon, Missouri, in which an operator was killed when his road grader struck a 10-inch propane pipeline.

In most cases, trenching and excavation activities are performed by subcontractors, which makes it more important to have good communication and subcontractor control. If subcontractors are responsible for locating utilities before digging, they should demonstrate to facility management that underground utilities have been located, identified, and marked before excavation begins. Construction supervisors and project managers should review the following documents related to excavation activities.
